Building Name: Science Building
Original Construction Date: 1956
Existing Programming: General Classrooms
 Chemistry
 English Offices
 Student Activities
 Student Club Offices
 Student Health Services
 EMT Program
 Photography Lab

Building Name: Student Center
Original Construction Date: 1956
Existing Programming: Athletics Office
 Food Court / Cafeteria
 Faculty Student Association
 Gift Shop
 Fitness Center
 Gymnasiums
 Little Theatre
 Physical Education Office

Building Name: Student Services Building

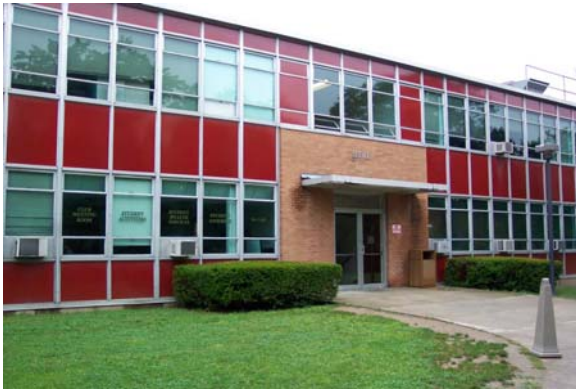
Exterior at south façade

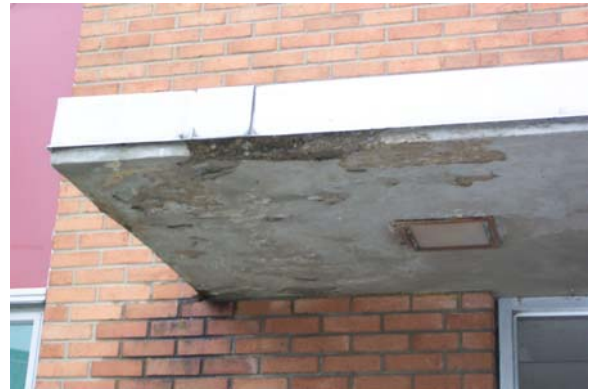
Roof: Ballasted built up roofing at original wing in major disrepair.
Structure: Reinforced concrete, concrete deck, slab on grade with perimeter crawlspace
Façade: Masonry and curtain wall system with metal panel and single pane glazing. Concrete entry canopies are deteriorating.

Stairwell exterior door deterioration due to winter salt usage allowing water infiltration
 Roof leaks in laboratory and has damaged casework
 Little to no cooling, window units used intermittently
 The following are in reference to the 1985 addition:
 Difficult to heat uniformly
 Basement not accessible
 Concrete spalling at entrance overhangs

Southwest entry canopy

- Have the building audited for ADA compliance to determine areas of renovation priority
- Replace roof
- Repair spalled concrete at canopies

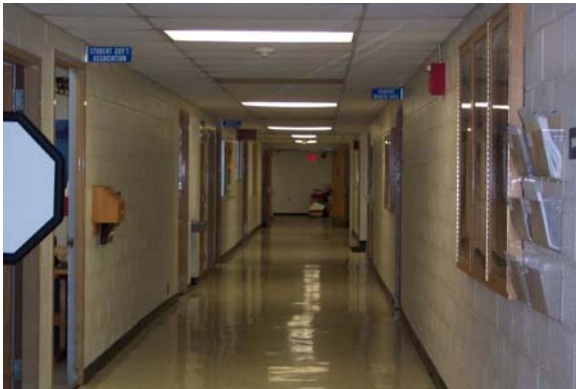
Ground floor corridor looking east

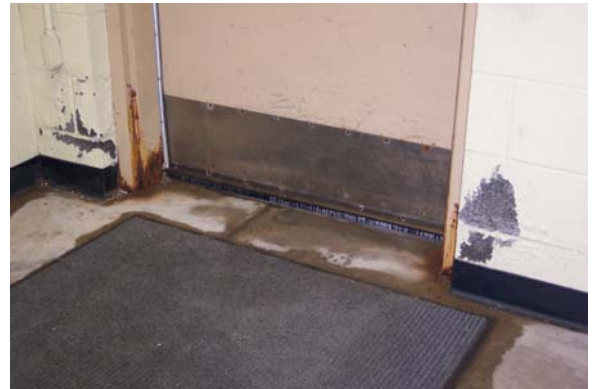
Door to east stair

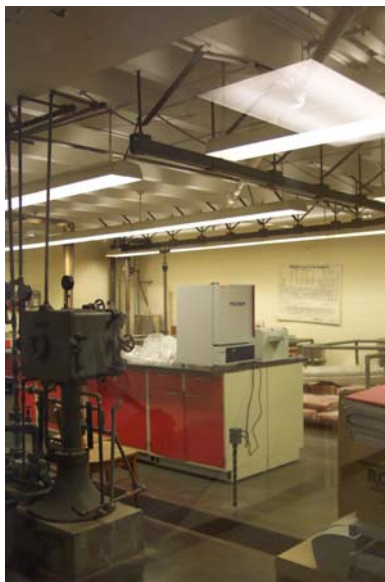
Unit Operations Lab S109

A small sectional cast iron, gas fired, steam boiler provides process steam for the Unit Operations Lab. The boiler is located within a non-rated service room in the lab that is not provided with adequate combustion air make-up. A relatively new gas-fired rooftop unit provides tempered make-up air to the west wing lab spaces.

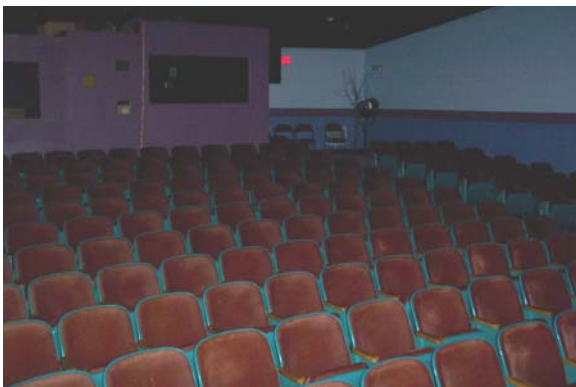
Theatre SC101

Forward floor in the theatre is damp
 Staining at exterior south wall
 Moisture infiltration at perimeter of the roof especially at north entrance
 East gym bleachers are binding and are difficult to operate

- Have the building audited for ADA compliance to determine areas of renovation priority
- Repair / reinforce flashing at the roof parapet to mitigate water migration through the wall
- Replace roof on original building
- Replace all storefront and glazing with thermally broken double pane units for better insulation
- Control moisture at theater slab
- Replace east gym bleachers
- Replace all outdated or damaged finishes

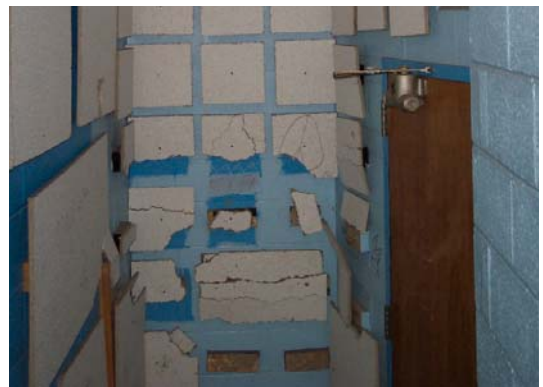
Vestibule at Theatre SC101

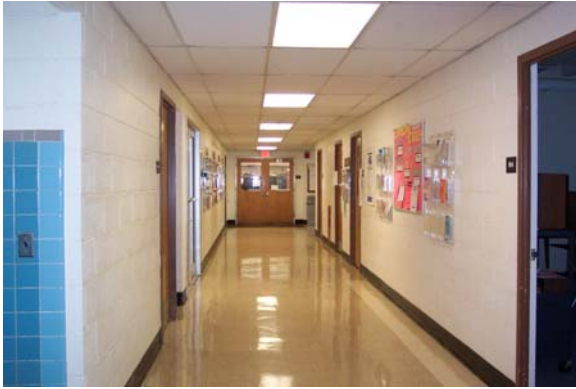
Ground Floor Corridor, looking east

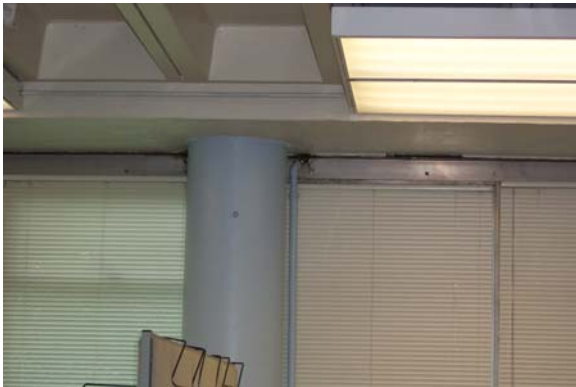
Column at Registrar SS105

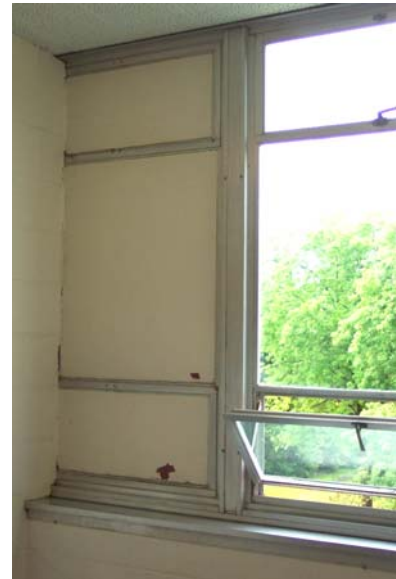
Window at Second Floor Stair Landing

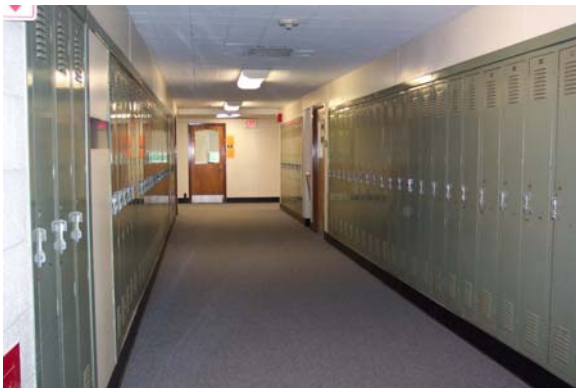
Second Floor Corridor, looking west
